Monterrey Condominium Incident

980 Cape Marco Dr.

Explosion Investigation Notes on the 10/21/2023 explosion
Monterrey Condominium Building, Marco Island, Florida
By HSM Consulting Fire Investigator Paul M. Haas CFIV

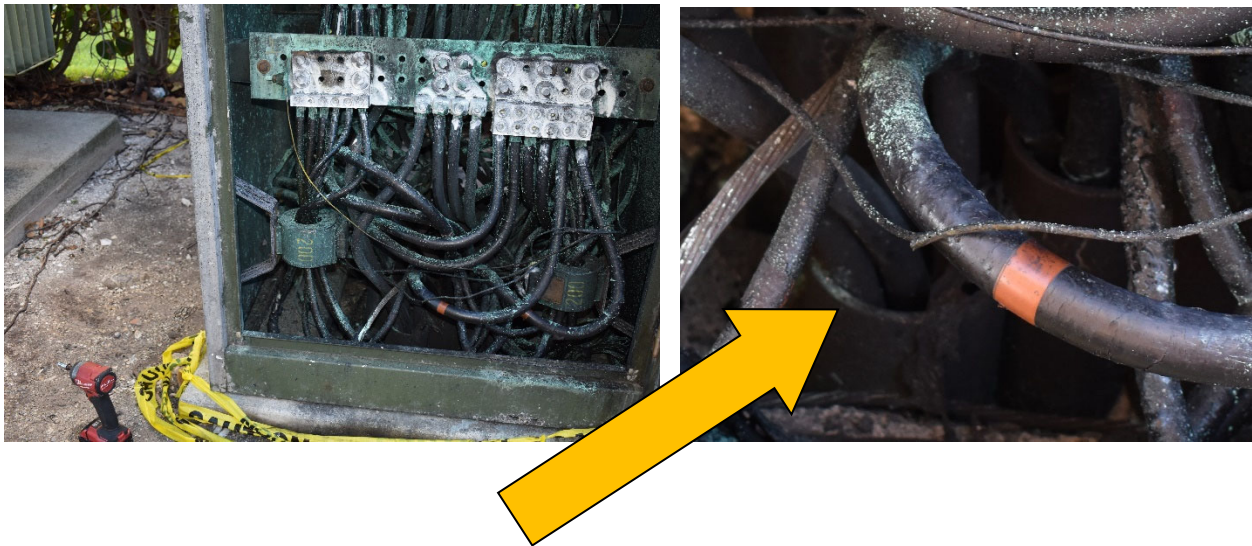
All the collected data formulated a non-disprovable hypothesis that the subject underground service lateral conduit for the Monterrey Condominiums was filled / flooded with last year's Hurricane Ian storm surge. The storm surge water remained in the underground conduit from the 2022 Hurricane Ian storm surge flooding. The electrical current leakage from preexisting installation damage to the underground lateral cables caused scuffs and or nicks in/on the underground laterals. Those areas of preexisting lateral cable damage were bridged by the conductive salt water. This bridging of the positive and neutral / grounds of the laterals electrically energized the water trapped in the conduit resulting in electrolysis with is the breaking of the molecular bonds between the hydrogen atoms and oxygen atoms that make up the water (H₂O) molecule. Over time, as electrical resistance increased, and the volume of water decreased / reduced due to redux of electrolysis. As water is converted to separate atoms of oxygen and hydrogen the volume of water reduces. When the water level in the conduit decreased due to electrolysis redux process, electrical resistance increased, and an eventual massive electrical resistance event occurred. This also increased the electrolysis process, in turn rapidly increasing the production of hydrogen gas. Bringing together the fuel (liberated hydrogen), oxygen (liberated oxygen), and heat from the increased electrical resistance within the conduit, resulting in the ignition of the hydrogen gas. Like a shotgun or cannon with 2 open barrel ends, the explosive overpressure and explosion byproducts discharge out both open ends of the underground conduit.

Open end of the conduit at the outside lateral junction box . This allowed storm surge water to easily enter and flood the underground conduit.

Having now encountered 2 similar combustion events, we feel it is of the highest importance to inspect and test an underground conduit that has or was flooded by water. We suggest that any underground lateral that was or has been flooded and possibly filled or contaminated with storm surge water be evaluated for hydrogen gas emission. This can be simply accomplished by using a Hydrogen Leak Detector to evaluate each conduit opening for hydrogen gas emissions.

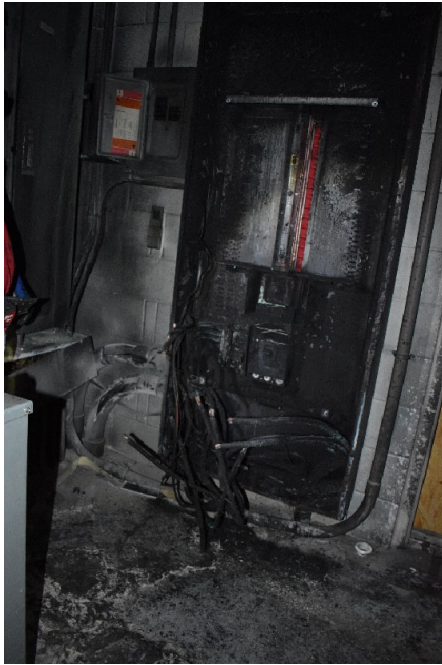
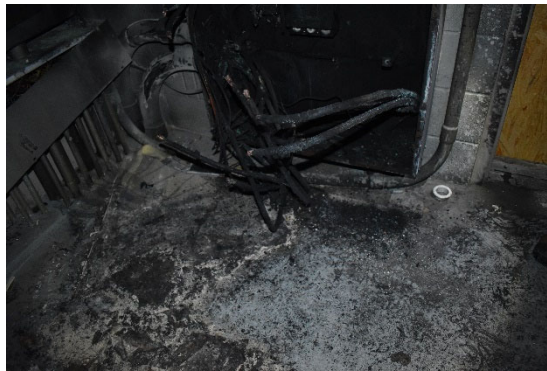
Examination of the electrical room found all patterns of soot and overpressure damage to confidently indicate an explosion overpressure of the low order originated within and from the main (3 of 3) disconnect panel box. This included a brief flash fire as the explosive overpressure extended into and out of the panel box.

Interior (3 of 3) Main Disconnect Panel. Note the presence of carbonaceous soot in and around the box.
