Monterrey Condominium Incident

980 Cape Marco Dr.

Explosion Investigation Notes on the 10/21/2023 explosion
Monterrey Condominium Building, Marco Island, Florida
By HSM Consulting Fire Investigator Paul M. Haas CFIV

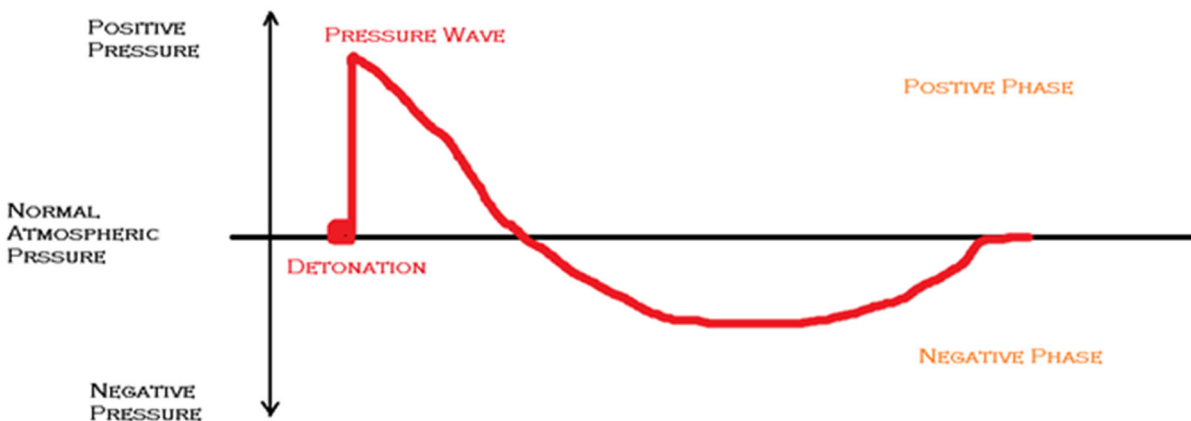
Typical explosion pressure-time history

NFPA 921: 22.3.1 Low-Order Damage states: "Low-order damage is characterized by walls bulged out or laid down, virtually intact, next to the structure. Roofs may be lifted slightly and returned to their approximate original position. Windows may be dislodged, sometimes without glass being broken. Debris produced is generally large and is moved short distances. Low-order damage is produced when the blast load is sufficient to fail structural connections of large surfaces, such as walls or roof, but insufficient to break up larger surfaces and accelerate debris to significant velocities."

NFPA 921: 22.8.2 Interpretation of Explosion Damage states: "The explosion damage to structures (low-order and high-order) is related to a number of factors. These include the fuel-to-air ratio, specific gravity of the fuel, turbulence effects, volume of the confining space, location and magnitude of the ignition source, venting, and the characteristic strength of the structure."

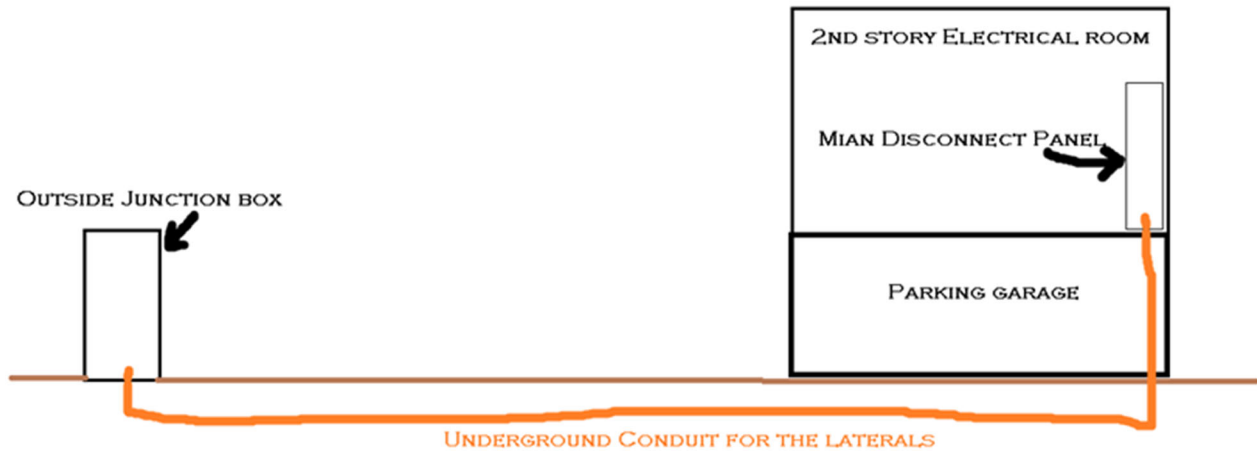
Having discovered 2 separate area of explosion damage, one at the exterior lateral junction box and the other inside the building within the 2nd story electrical room main (3 of 3) breaker panel box, we had to examine and explore if the 2 separate area of explosion damage were connected or not connected. We found the “connection” between those 2 areas was the underground conduit that carried the electrical service laterals from the outside junction box underground to the interior 2nd floor electrical room.

All collected data formulated the hypotheses that the explosive event originated within the underground conduit for the electrical service laterals. All other competing explosion origin hypotheses were confidently disproven. The next phase of the post blast investigation was to see if the cause of the explosion could be determined. Interest and attention were given to the underground lateral conduit connection between the exterior lateral junction box and the interior main disconnect panel box. Examination of the damage areas including the conduit confidently determined that an arc or arc flash event could not have generated sufficient explosive pressures to cause the overpressure and carbonaceous soot staining damage found. Examination of the damaged areas found no obvious signs or evidence that a solid or liquid fuel was involved. We then used the data collected to formulate the hypothesis that hydrogen gas was the fuel. This hypothesis included the findings of the lateral conduit at the exterior junction box were open and about a year ago that exterior junction box was flooded with Hurricane Ian storm surge water from the nearby Gulf of Mexico.

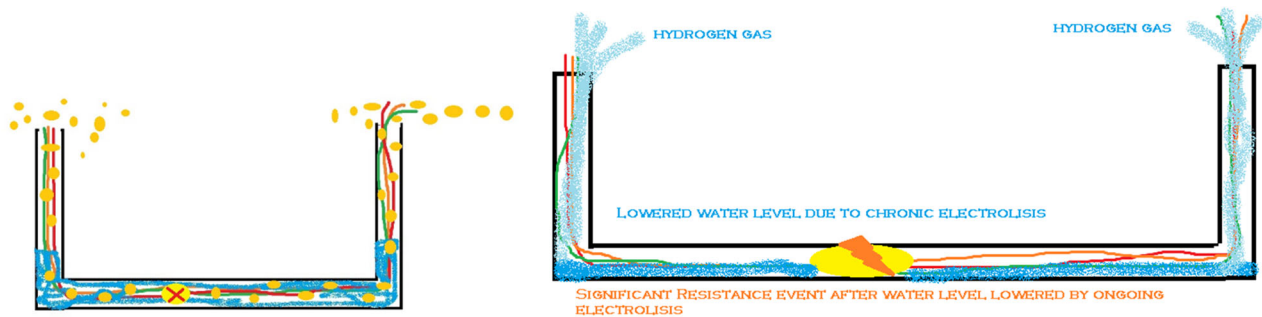
All the collected data formulated a non-disprovable hypothesis that the subject underground service lateral conduit for the Monterrey Condominiums was filled / flooded with last year's Hurricane Ian storm surge. The storm surge water remained in the underground conduit from the 2022 Hurricane Ian storm surge flooding. The electrical current leakage from preexisting installation damage to the underground lateral cables caused scuffs and or nicks in/on the underground laterals. Those areas of preexisting lateral cable damage were bridged by the conductive salt water. This bridging of the positive and neutral / grounds of the laterals electrically energized the water trapped in the conduit resulting in electrolysis with is the breaking of the molecular bonds between the hydrogen atoms and oxygen atoms that make up the water (H₂O) molecule. Over time, as electrical resistance increased, and the volume of water decreased / reduced due to redux of electrolysis. As water is converted to separate atoms of oxygen and hydrogen the volume of water reduces. When the water level in the conduit decreased due to electrolysis redux process, electrical resistance increased, and an eventual massive electrical resistance event occurred. This also increased the electrolysis process, in turn rapidly increasing the production of hydrogen gas. Bringing together the fuel (liberated hydrogen), oxygen (liberated oxygen), and heat from the increased electrical resistance within the conduit, resulting in the ignition of the hydrogen gas. Like a shotgun or cannon with 2 open barrel ends, the explosive overpressure and explosion byproducts discharge out both open ends of the underground conduit.

Slow to rapid electrolysis

The cause of the explosion was confidently determined to be the rapid (explosive) ignition of hydrogen gas that was liberated from the flooded underground electrical service lateral conduit after the water in the conduit was electrolyzed by electrical current leaking from the underground service laterals within that conduit. Over time, as electrical resistance increased, and the volume of water decreased / reduced due to redux of electrolysis. As liquid water was converted to oxygen and hydrogen gas the liquid water volume was reduced. When the water level in the conduit decreased due to electrolysis, electrical resistance increased, and an eventual massive electrical resistance event occurred. The electrolysis
